SELECTIVE DEMOLITION

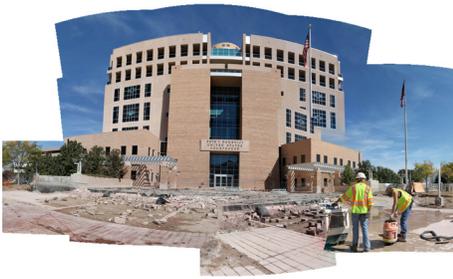
IMAGE 6

Selective demolition and concrete harvesting of the existing plaza.

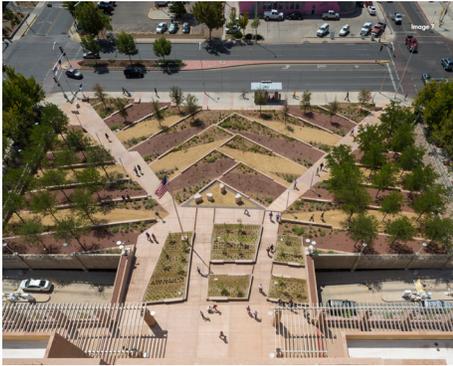
IMAGE 7

Gone are the water-intensive lawns and leaky fountain. In their place are terraced gardens comprised of over 79% native plants uniquely suited to the hydrology of New Mexico's Rio Grande Basin.

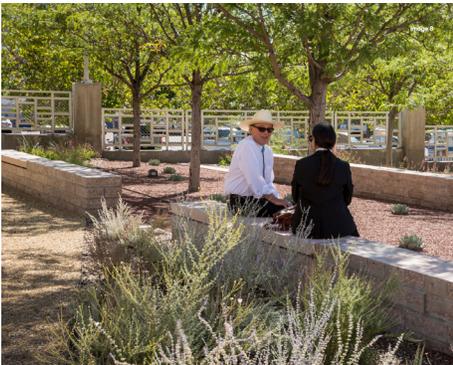
IMAGE 8

Recycled concrete block walls provide shaded, informal seating areas.
