Comprised of a 15-acre lake and 14 acres of surrounding park space, Echo Park Lake is tightly wrapped by multi-family residential, places of worship, and the 101 Freeway. This site diagram illustrates the rehabilitation project's improvements including new lake edges and liner, constructed wetlands, revitalized planting, habitat enhancements, new pathways and furnishings, and LED lighting. It was Echo Park Lake's first complete overhaul in its 120-year history.

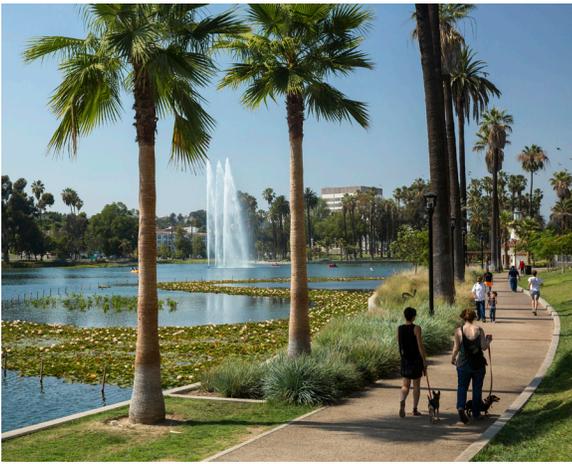
Image 2

A designated Historic-Cultural landmark because of its "Picturesque" landscape style, some of the park's defining characteristics include long views across the lake and gently winding pathways flanked by palm allees. Effort was made to preserve such existing features as well as re-create the gently curving geometry that had been lost over time.

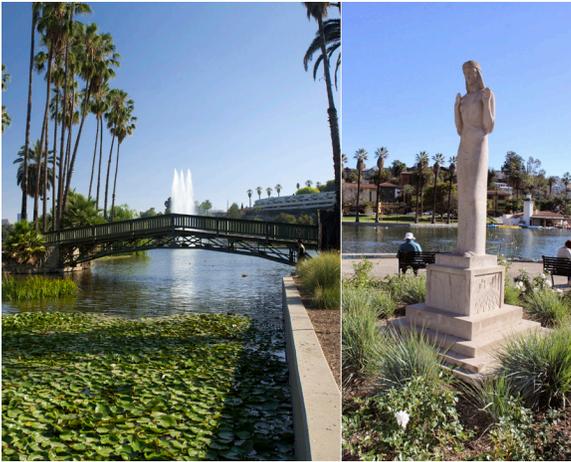
Image 3

Various park features also contribute to the park's status as a Historic-Cultural landmark and convey a strong sense of place. A steel and wooden footbridge, dating back to the 1930's, was preserved in place. Additionally, the WPA-era "Lady of the Lake" statue was restored and returned to its original, prominent location at the lake's peninsula after many years of neglect.

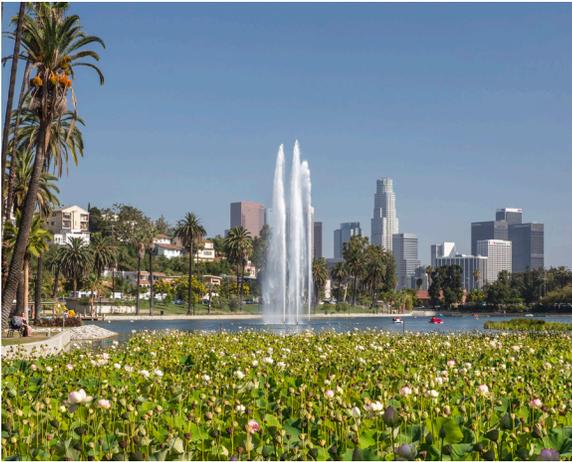
Image 4

This once-iconic Los Angeles view had been drastically altered in the years prior to the rehabilitation project due to the disappearance of the lake's historic lotus bed. Project designers, engineers, and biologists worked with lotus experts to optimize conditions for the return of the lotus, and worked closely with aquatic growers to ensure the selected material and planting methods would yield a bountiful bloom. This image shows the new lotus bed, with downtown Los Angeles in the background.

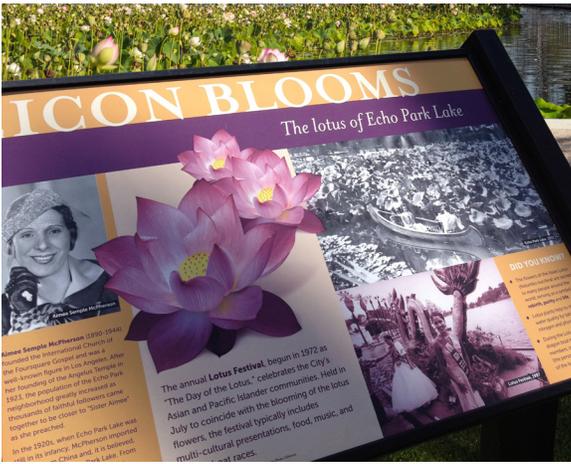
Image 5

A series of seven interpretive signs help to inform park visitors about the rehabilitation project, the site's history, park stewardship, and the function of the lake's new wetlands. The sign content and graphics were designed as a collaborative effort between the project's landscape architect and environmental graphic designer. This sign depicts the history of the lake's famous lotus plants.

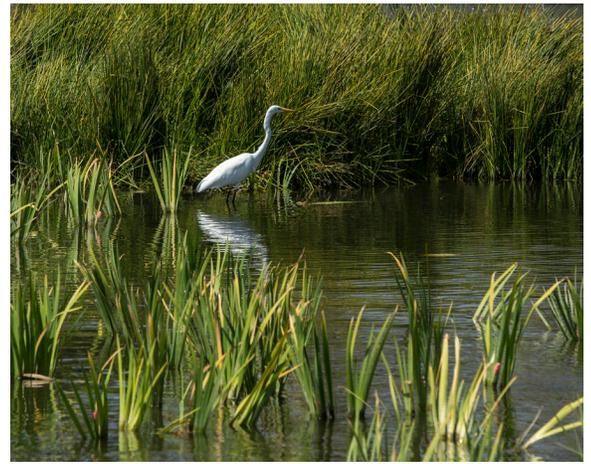
Image 6

Almost four acres of wetland planting was carefully integrated into the project with the primary purpose of naturally treating stormwater runoff that enters the lake through City of Los Angeles and County of Los Angeles storm drains. The project re-configured lake inlets to accept dry-season flow (typically the most polluted of flows) at a volume intended to offset evaporative loss, minimizing potable water use. Secondly, the added aquatic planting provides additional wildlife habitat for both domestic and migratory water fowl.

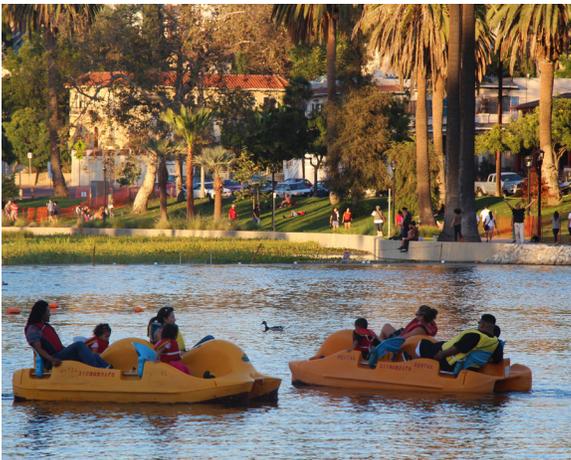
Image 7

In addition to treatment potential, the selection of aquatic plant material and layout of the wetlands took into consideration the preservation of key views, in-lake recreation (as seen in this image), and the needs of fisherman who take advantage of catch-and-release fishing.

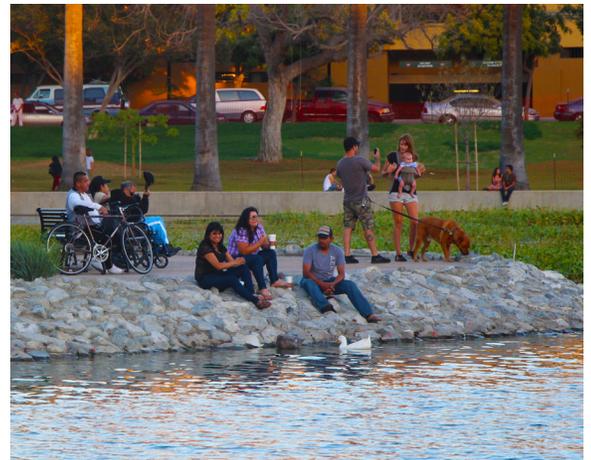
Image 8

The design team studied images and descriptions of the lake throughout its historic period of significance (1870-1943) to determine an approach to re-building the crumbling lake edges. Balancing safety, cost, aesthetics, and historic integrity, three types of edges were ultimately integrated together: vertical concrete walls, rock banks, and vegetated slopes—each creating a different relationship between park users and the lake.

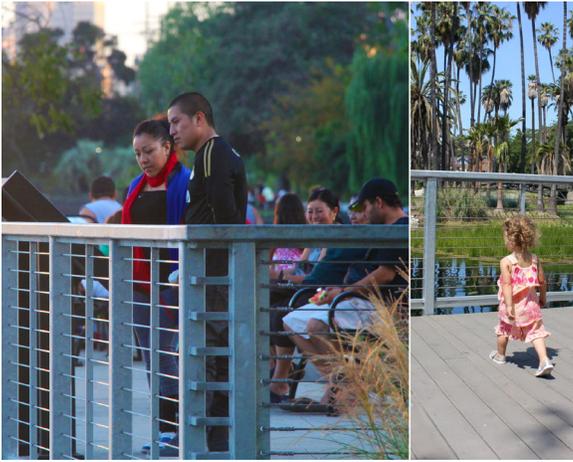
Image 9

Turning eyesores into amenities, two existing utilitarian stormwater inlet structures were modified to incorporate boardwalk features and lake overlooks. Once avoided by park visitors, these areas now serve as special nodes around the lake.

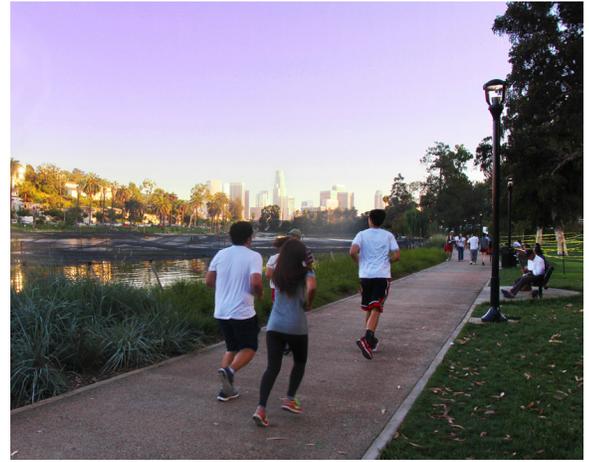
Image 10

With sustainability a high priority for both the design team and City of Los Angeles, the project includes porous concrete paving paths (replacing asphalt), drought-tolerant planting (of similar form to the park's historic palette), and pedestrian-scale LED lighting (replacing high-pressure sodium cobra-head lights). The park's grading was also slightly modified to reduce the direct flow of runoff and sediment into the lake.
