# SOCAL ASLA 2014 Quality of Life Awards

## Category: Design - Institutional

**Project:** LA Law Library

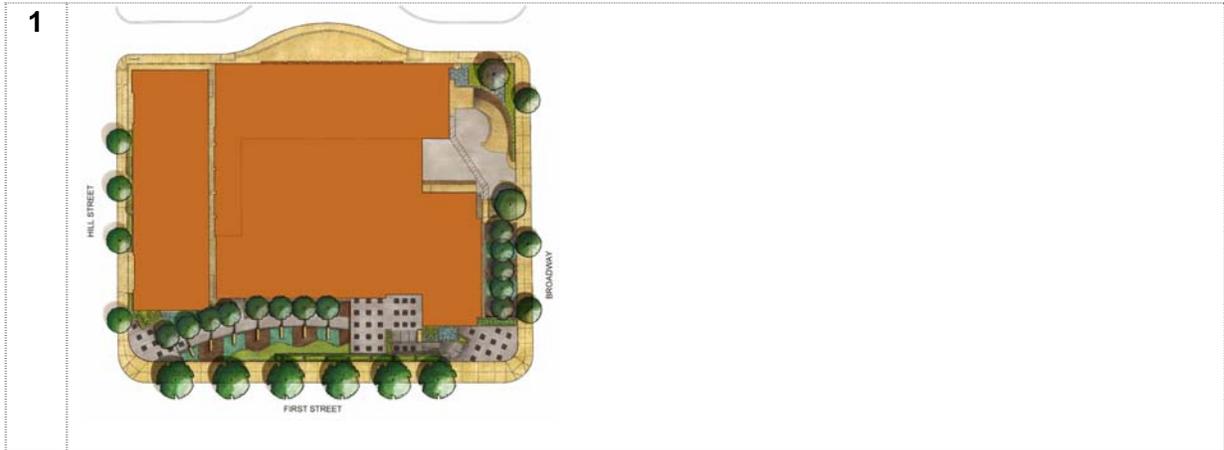
Overall site plan shows the seamless ADA access design to the site from Hill Street and Broadway and new staircase design that “opens” visibility and access to Broadway. (see image #7 for old staircase layout) This color rendering shows an early version of dark granite insets forming squares in the hardscape pattern. This was later changed to a pattern of light and dark concrete bands.

Before image of the existing stairs and stepped planters off of First Street, built in the 1960's, which had "blind spots" that visually closed access to the front of the building.

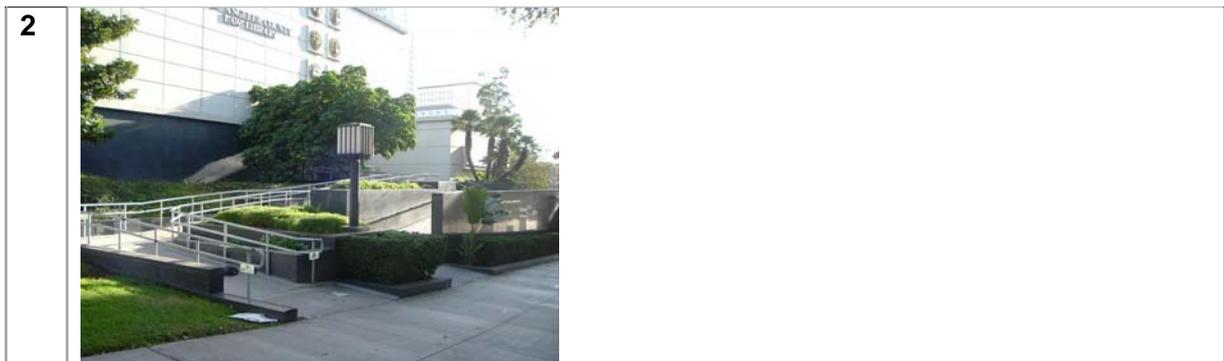
Before image of the two ADA access ramps off of First Street both of which no longer met current code. The complex nature of the building to the hilly site made ADA access a central element of the new design solution.

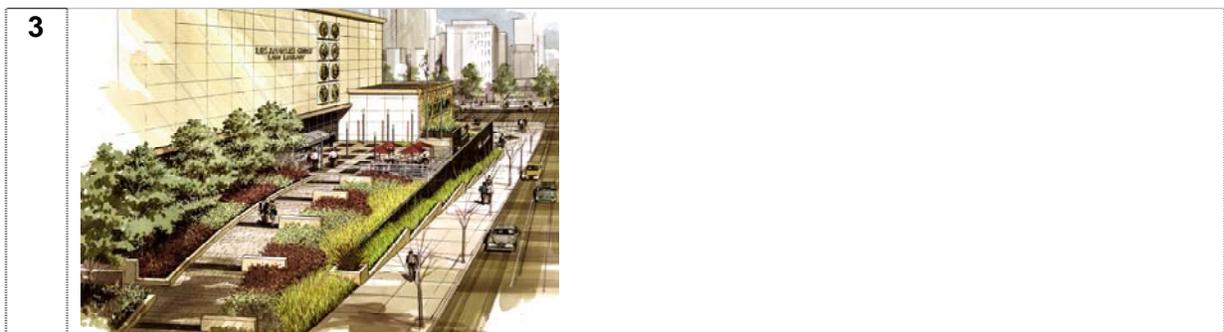
Perspective rendering looking east from the corner of Hill and First Street depicts the connectivity of the curved sloping walkway from the upper edge of the site at Hill Street to Broadway at the lower end. This concept provided a path of travel that was ADA code compliant, without handrails and not to separate one user from another.

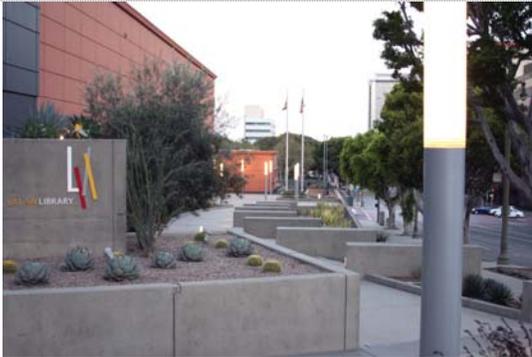
4

A series of spaces unfold along the walk including an entrance plaza that accommodates library programs and other functions. Repetitive 'fin' walls along the walk punctuate smaller garden spaces that provide for informal seating and conversation.

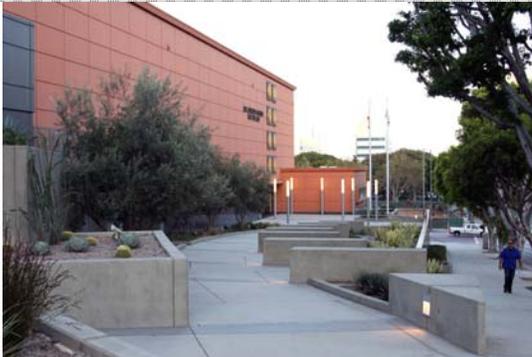
5

The walkway signifies a seamless integration of pedestrian access for all pedestrians regardless of disability.

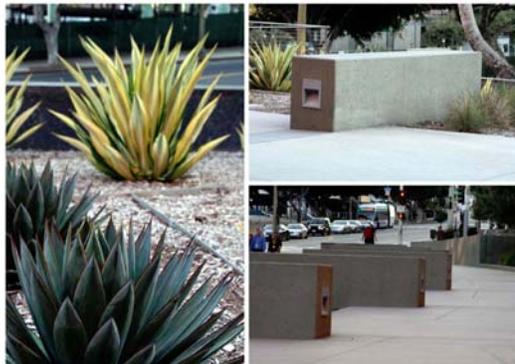
6

The Landscape Architects design philosophy was highly focused on sustainability - integrating drought tolerant, low maintenance planting that provided color and softened the streetscape. This landscape has created a comfortable environment for all user and stakeholders, while also maintaining security.

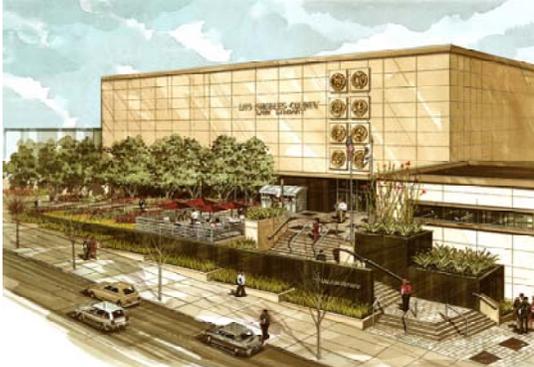
8

Perspective rendering looking north from the corner of First Street and Broadway depicts the overall renovations to the Library and illustrates how the new steps "open up the site" for better visual safety and access to the front entrance.

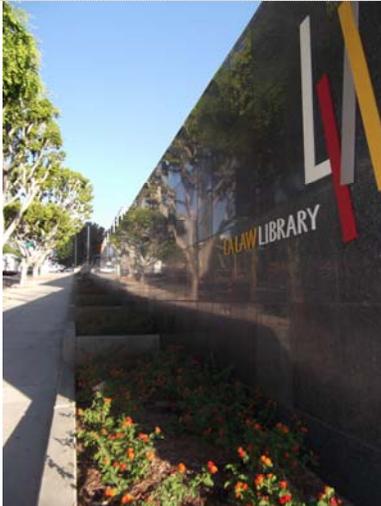
9

The new refaced granite planter wall needed to match the original granite façade of the building from the 1960's. Note the new library logo on the granite wall. This also was a part of a complete "house" makeover to bring the LA Law Library into the 21<sup>st</sup> century.

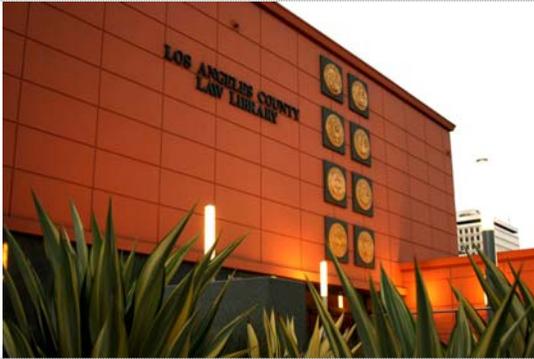
10

Detail image of the Landscape Architects effort in coordinating refurbished & repainted finishes to the the building with the landscape finishes, planting and lighting.
